**An Initial Review of  
the Fire Safety of  
Large Insulated  
Sandwich Panels**

**Fire Research Station**

FRDG Publication Number 3/97

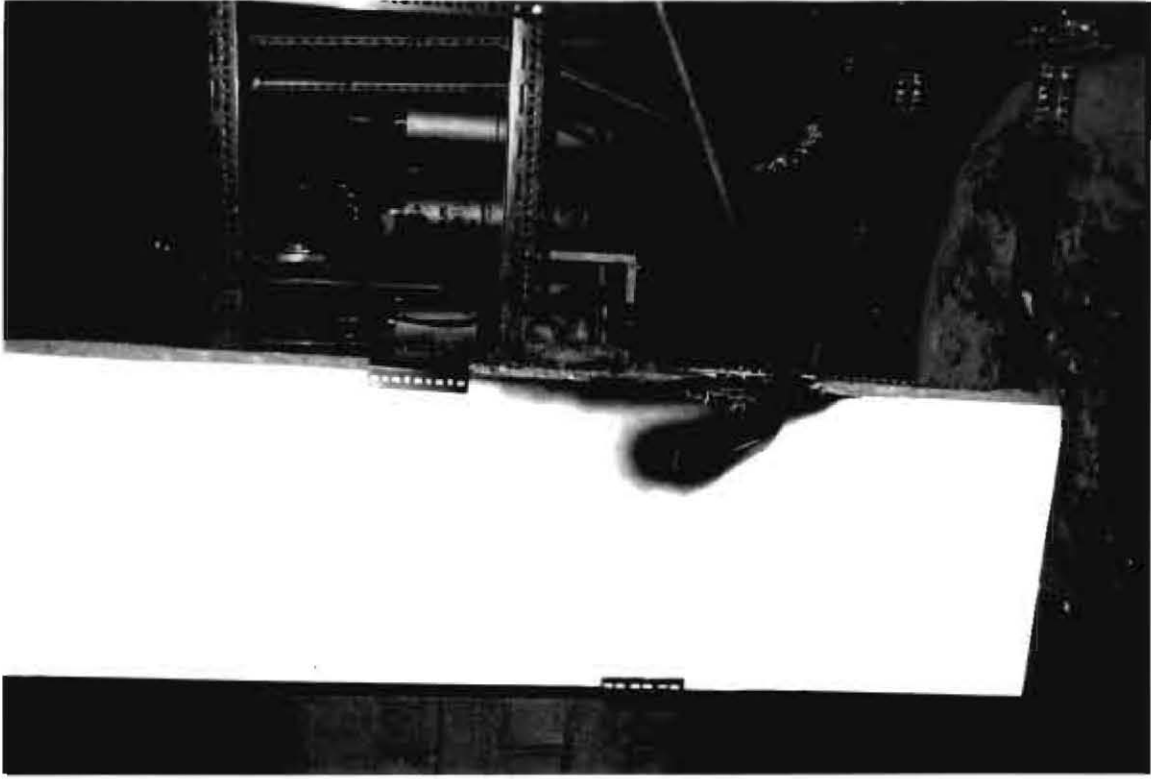
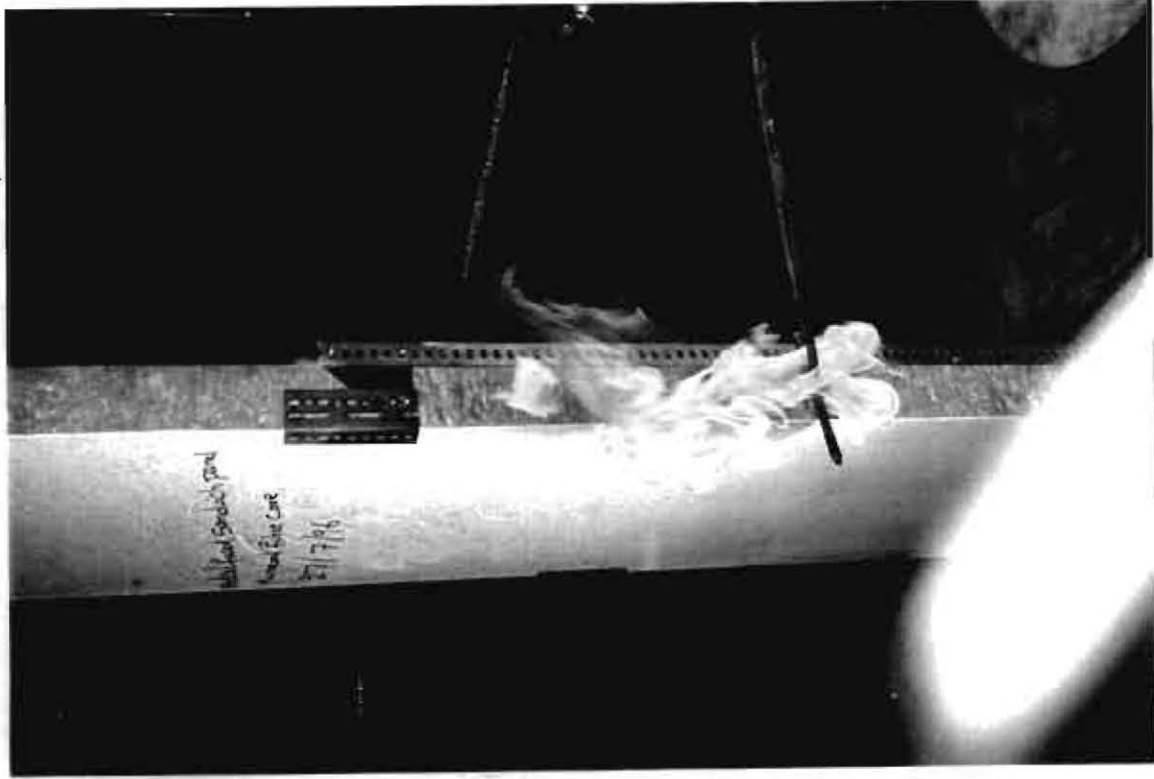
Mineral wool panel - during test and after

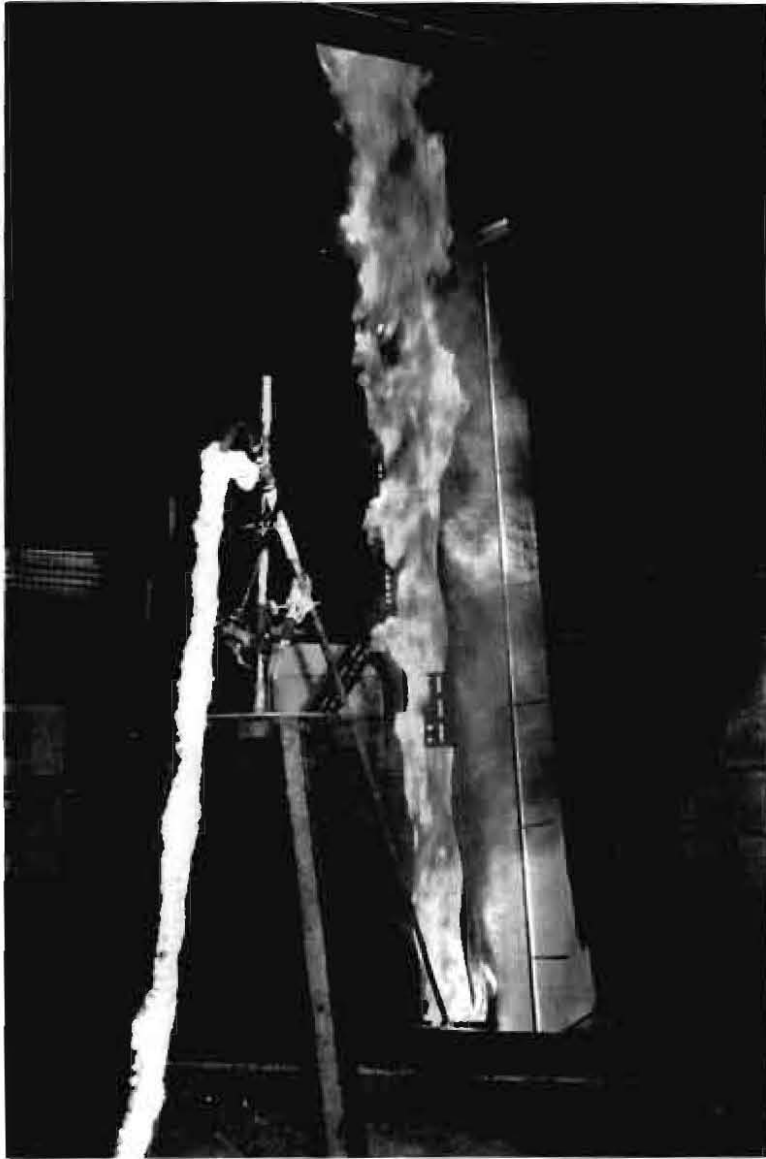
**Polystyrene jointed panel test**

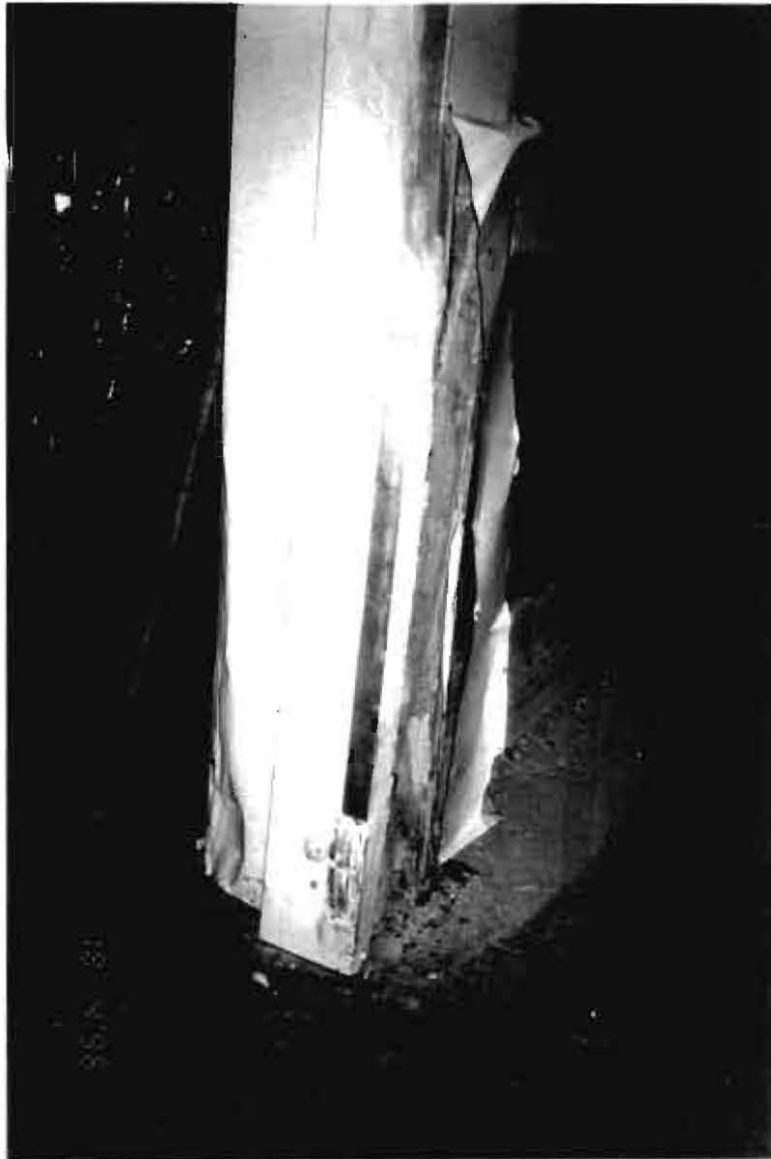
**Typical impact damage to door frame base (from fork lift truck)**

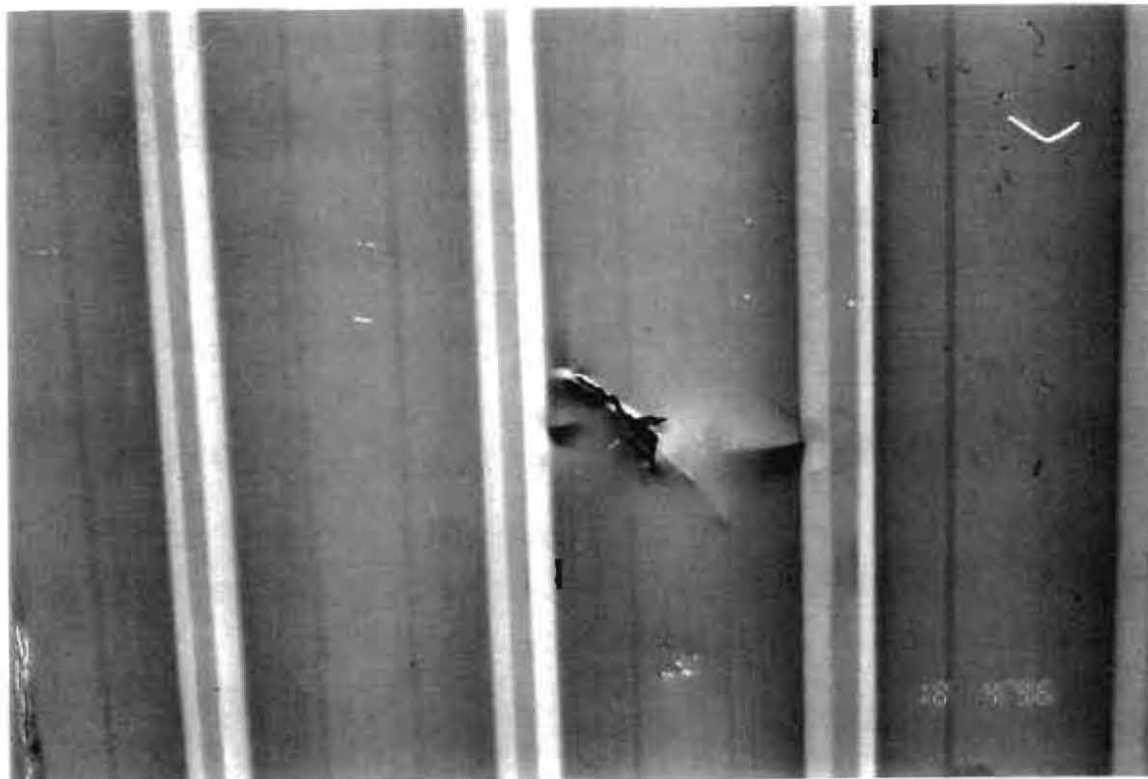
**Exterior wall of building showing puncture (from fork lift truck).**

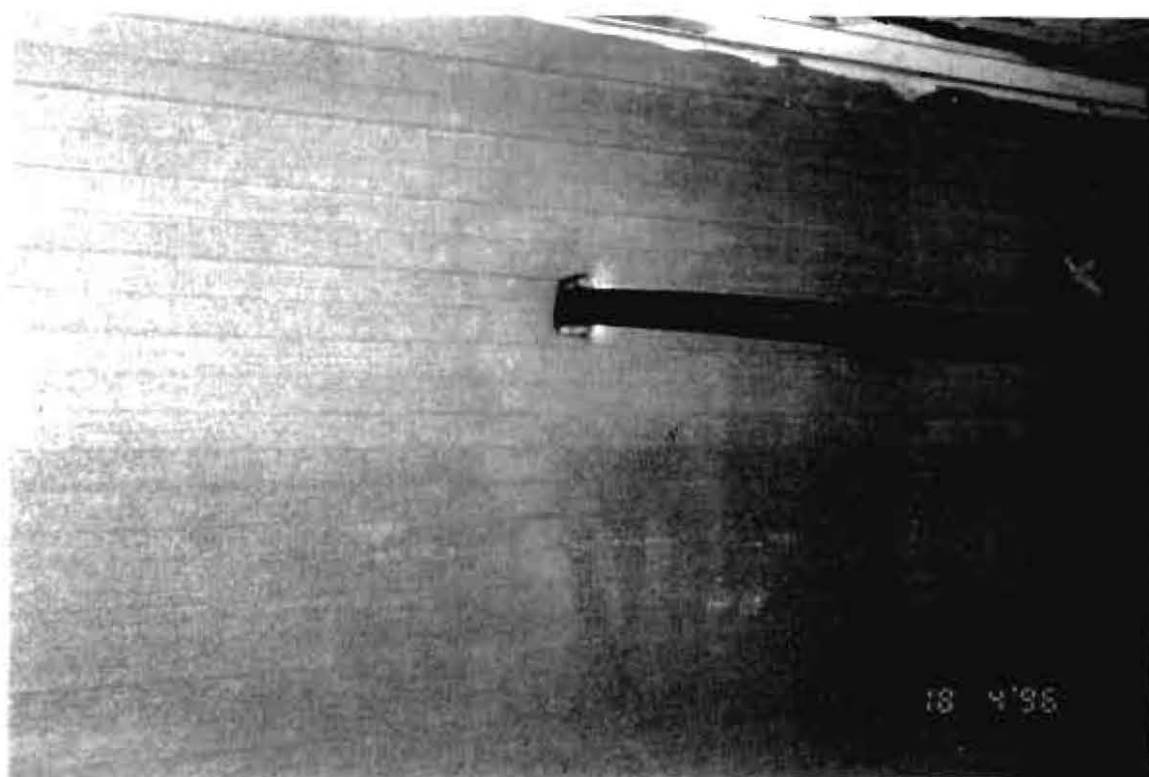
**Penetration of services through ceiling panels  
Note ice build up on pipes.**
